PNE-516  
FINAL REPORT

# PROJECT PRE-SCHOONER II

## POSTSHOT GEOLOGIC AND ENGINEERING PROPERTIES INVESTIGATIONS

ALTON D. FRANDSEN

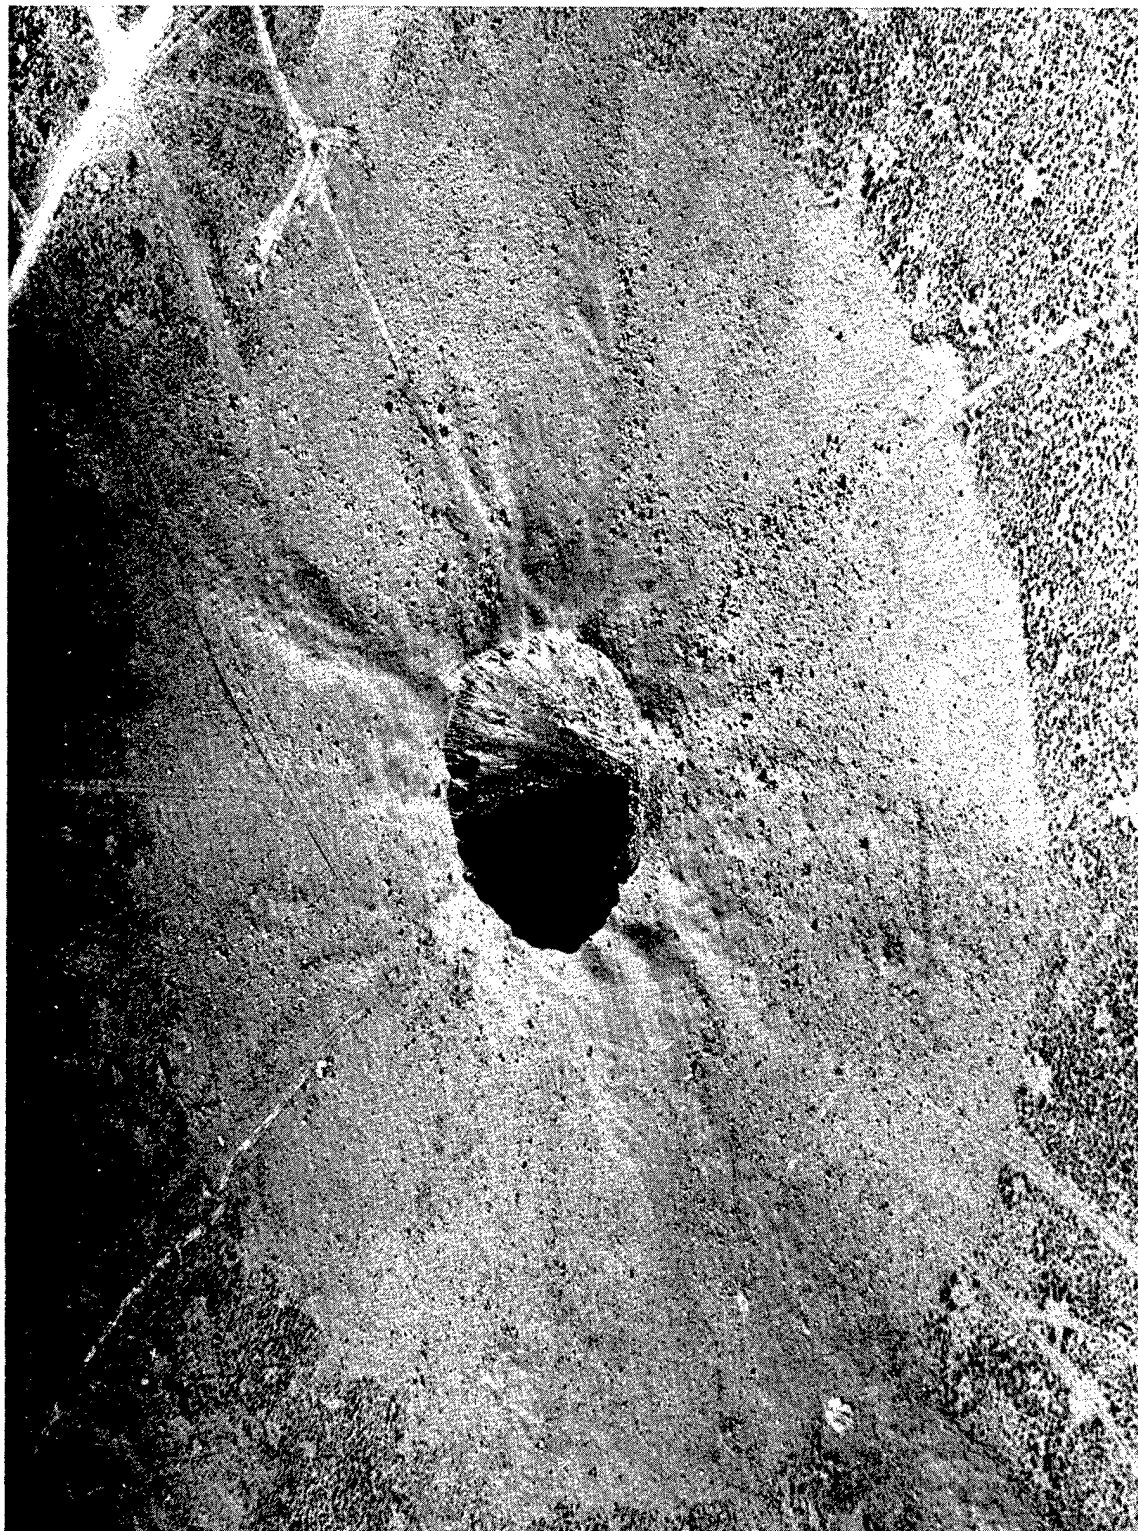
Pre-Schooner II Crater.

The Pre-Schooner II Event was a chemical explosive single-charge cratering experiment in hard, dry rock. The detonation was centered 71 feet below the ground surface and consisted of approximately 85.5 tons of nitromethane. The explosion produced a crater with an apparent radius of 95.2 feet and an apparent crater depth of 60.7 feet.

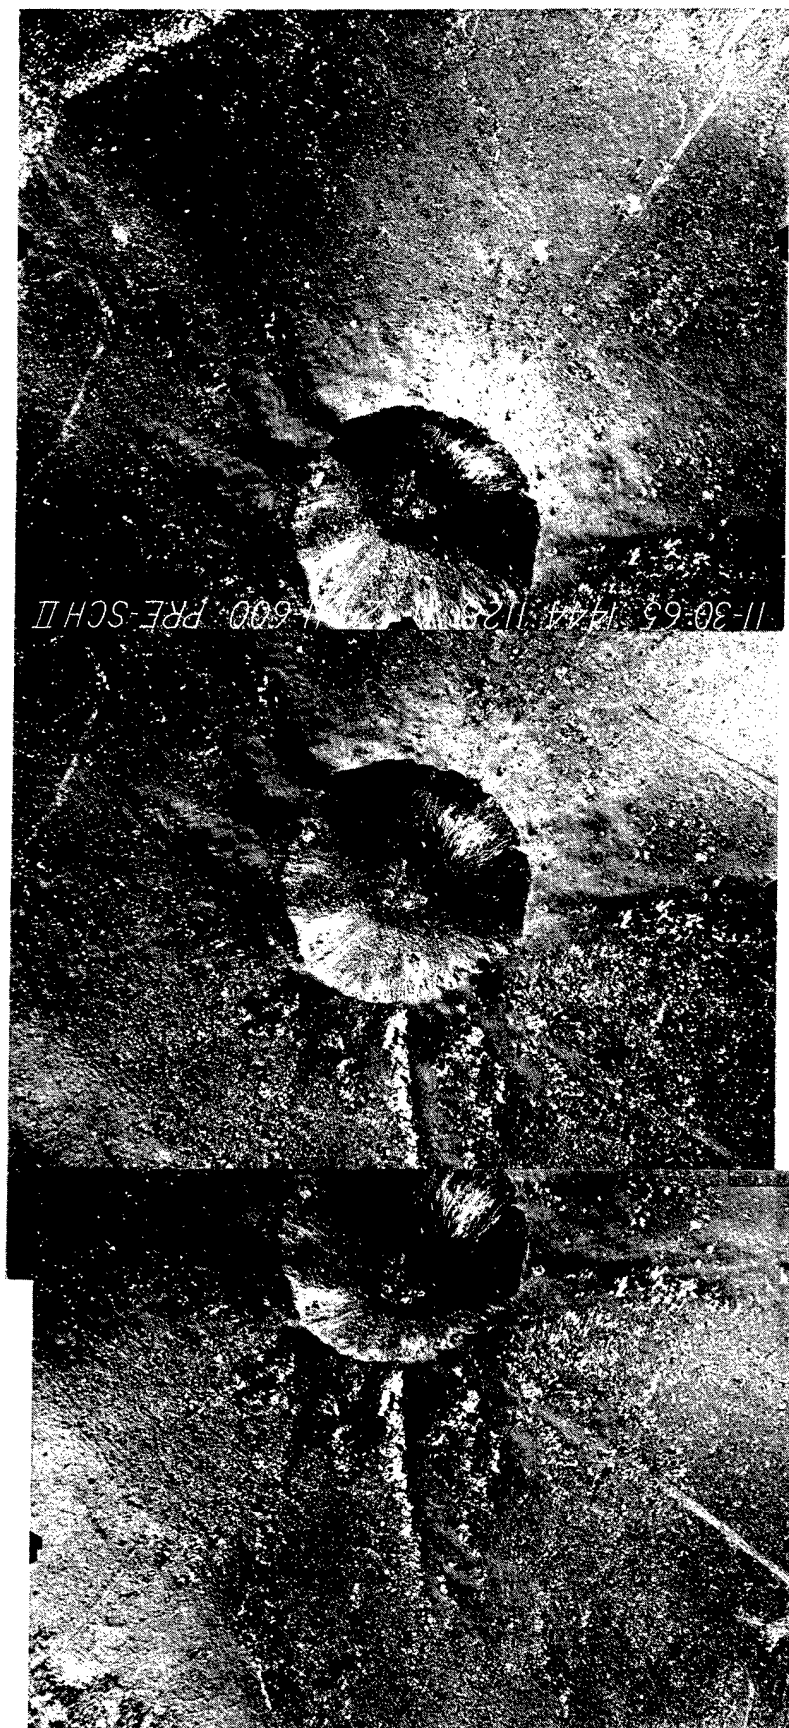
Figure 3.2 Postshot aerial photo prior to commencing excavations (photos grouped for stereoscopic viewing).

possible. A final aerial photograph and map were made at the completion of all excavation. Photographic stereoscopic pairs of the excavation phases, and corresponding topographic maps, are shown in Figures 3.2 through 3.7.

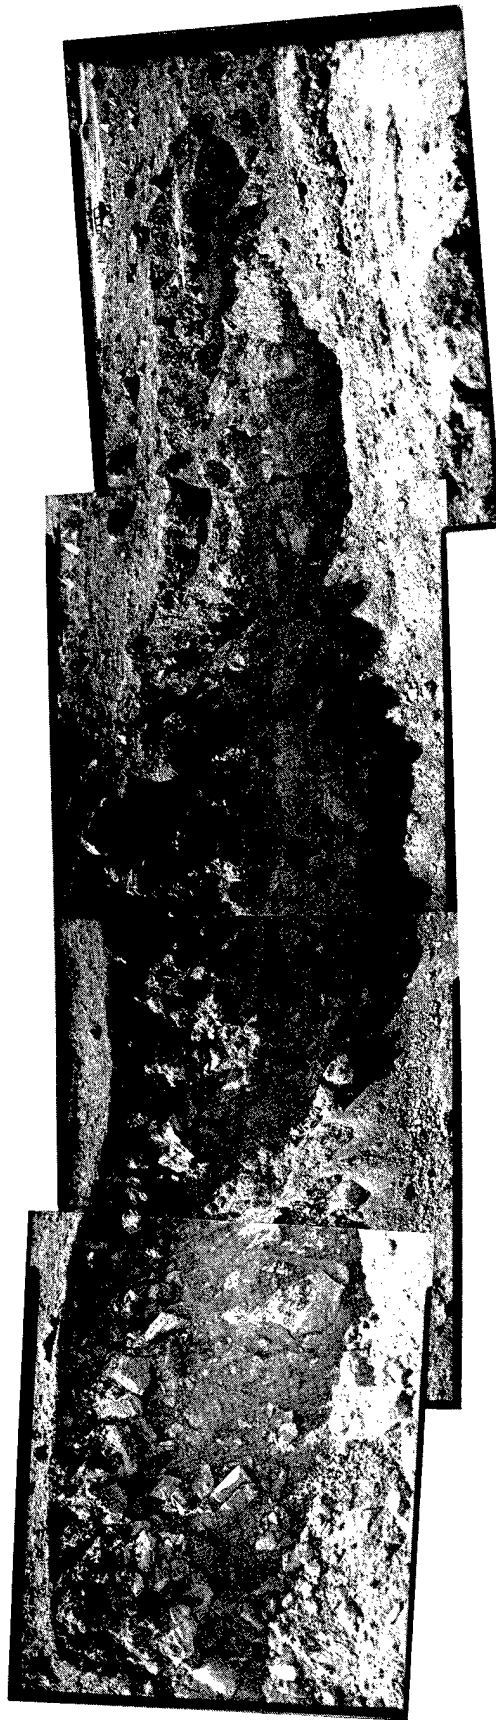
Figure 4.7 Ground profiles from Trench No. 2, west wall.

After the trenches were excavated, one wall of each trench was examined and mapped to delineate the true crater boundary and amount of uplift. The results of this mapping are shown in Figures 4.6 through 4.9 for Trenches No. 1, and No. 3. The true crater radius and amount of uplift are listed in Table 4.4.

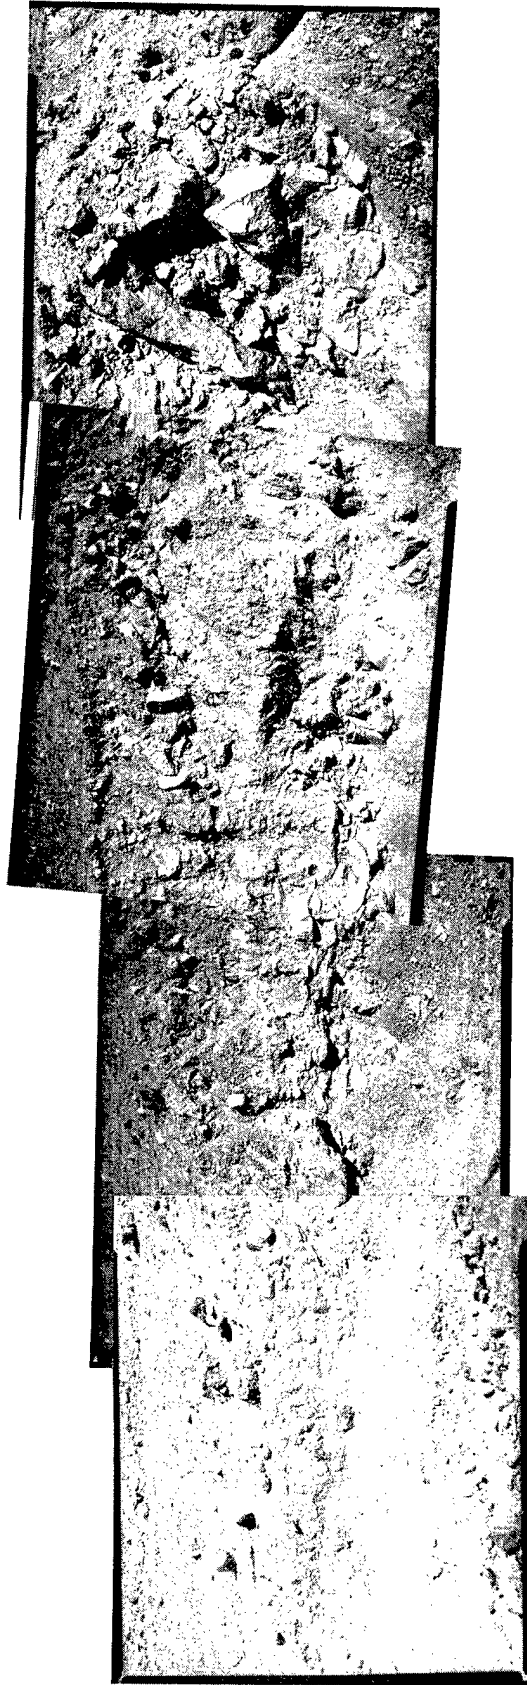
Figure 4.8 Ground profiles from Trench No. 2, east wall.

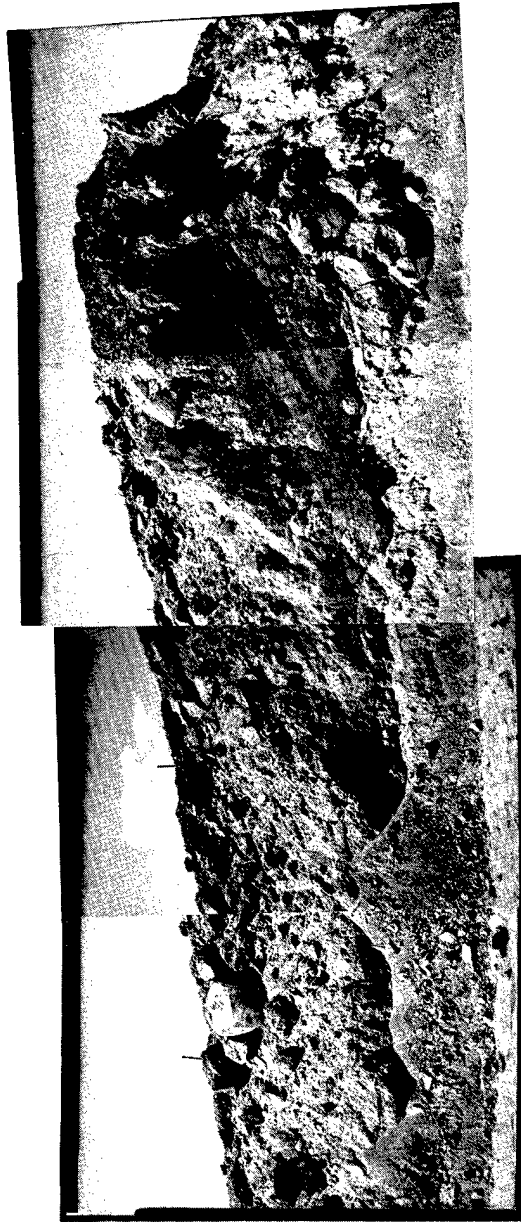
Figure 4.9 Ground profiles from Trench No. 3.
